case study

Custom Separator Protects Steel Mill's De-Scaling Pumps Burns Harbor, IN

Application:	Custom JSK Separator At Steel Mill
Solids:	Sand, Silt, Zebra Mussels
Liquid:	Lake Michigan Water

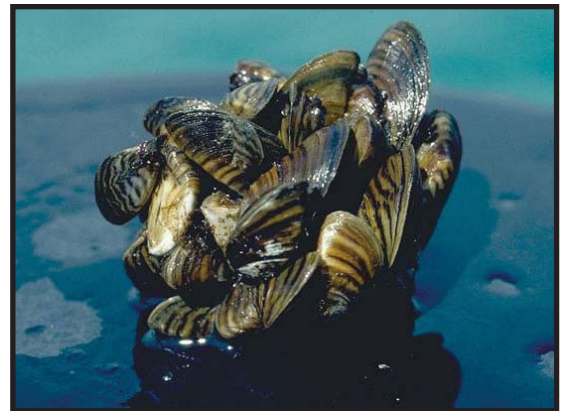
Zebra mussels like these were forcing the intake screens to pre-maturely backwash

The second issue was zebra mussels attaching themselves to the piping that feeds the pumps and the self-cleaning screens that were being used to protect the pumps. These harmful mussels form a consistency equal to concrete, causing the self-cleaning screens to experience a drop in pressure, forcing them into premature back-washing cycles. The problem was so bad, it forced the facility to by-pass the screens all together, which in turn caused problems with the pumps and spray nozzles.

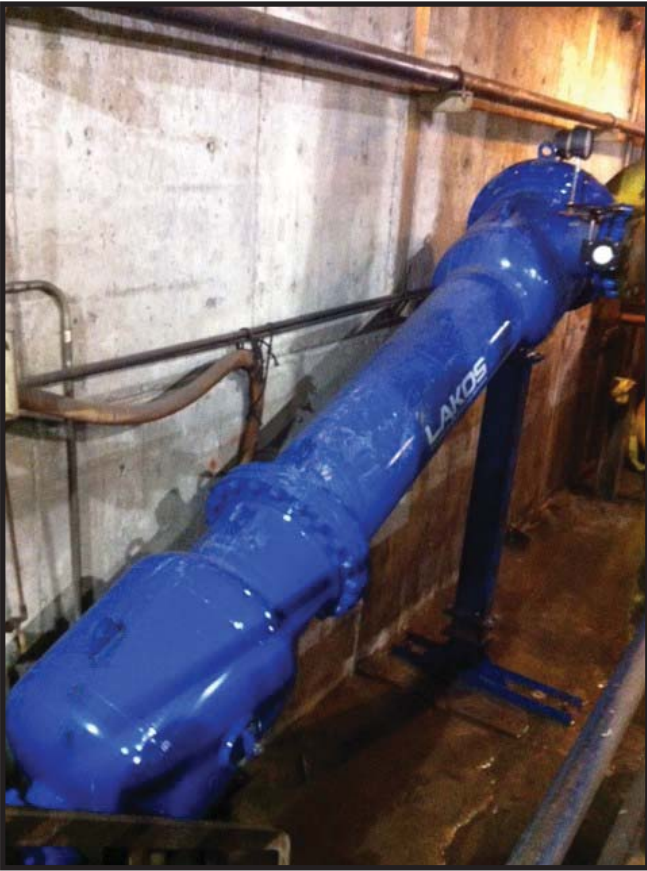
The JSK-2650-L/LFG industrial separator has a flow rate of 2650 - 4900 GPM

Solution: LAKOS and the local distributor worked with the on site mechanical engineer and came up with a solution for protecting the pump and preventing zebra mussel buildup. A custom model JSK-2650-L/FLG was designed using a special, all natural and environmentally safe interior coating that did not allow the zebra mussels to attach themselves to the separator. Within the first month of the installation, the mill was convinced of the efficiency of the separator.
